# STORM DAMAGE ASSESSMENT

Aerial Documentation Report

**Jul 20, 2025 ? HAIL**

2282 Panoramic Circle, Apopka, FL, 32708

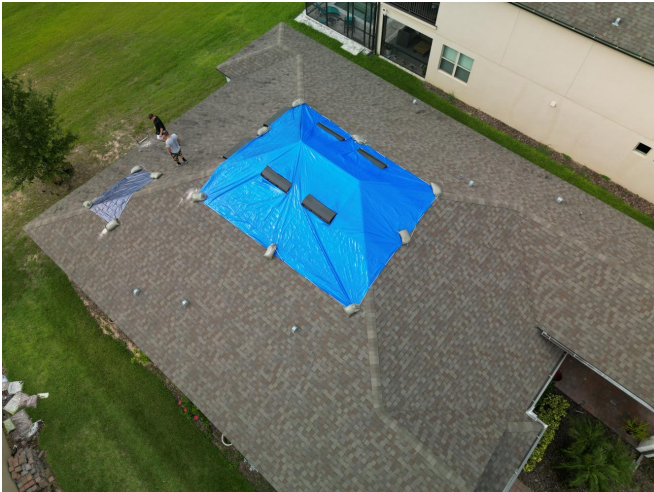
storm debris visible
