SPACE COAST EMERGENCY TARPING

# STORM EVENT & AERIAL ROOF DOCUMENTATION REPORT

2282 Panoramic Circle, Apopka, FL, 32708

May 5, 2026

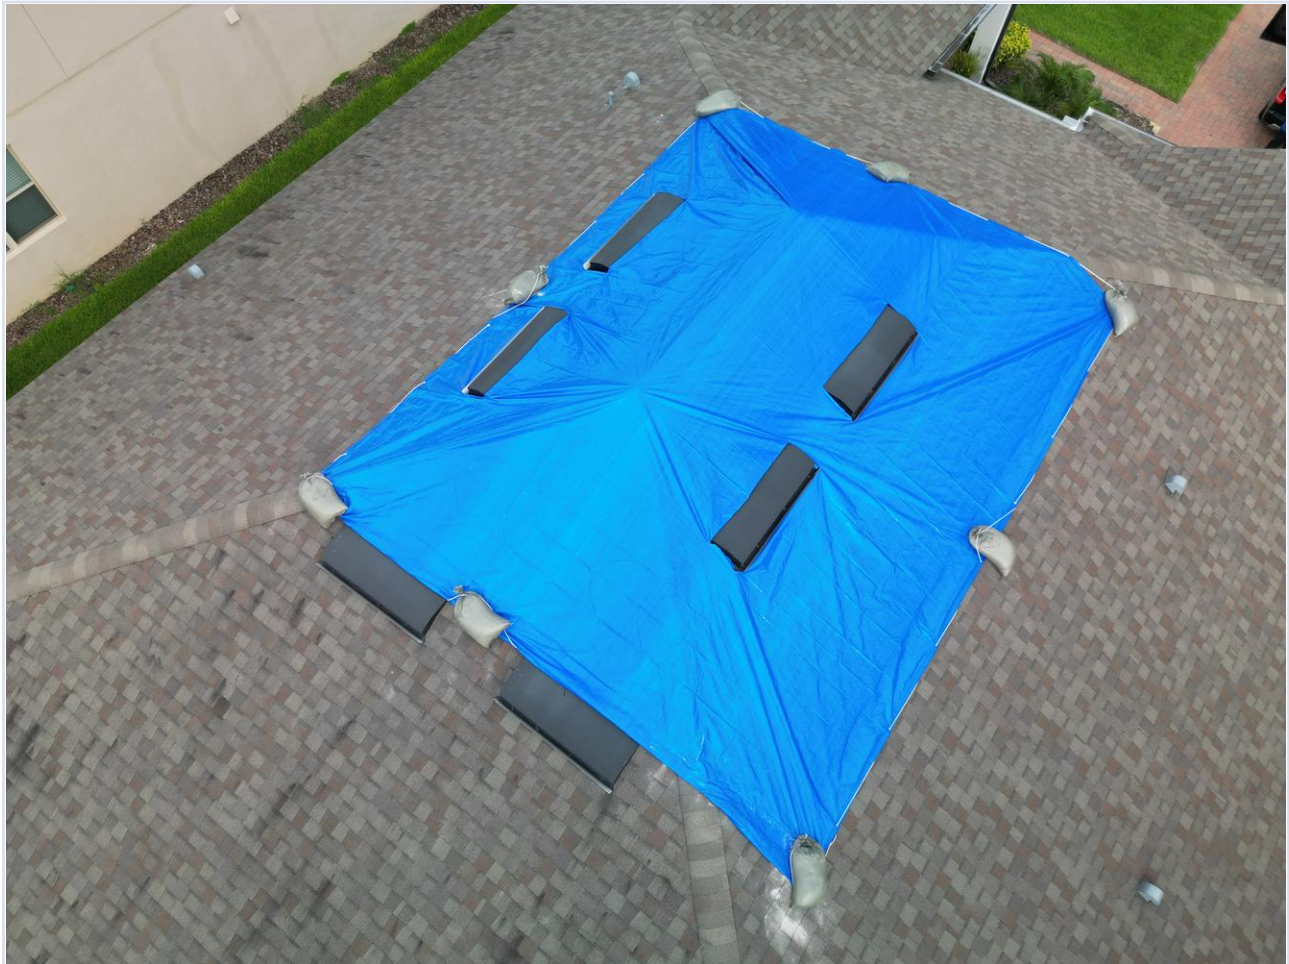
## Roof overview - overview documentation

Storm debris (3)

Possible granule loss (2)

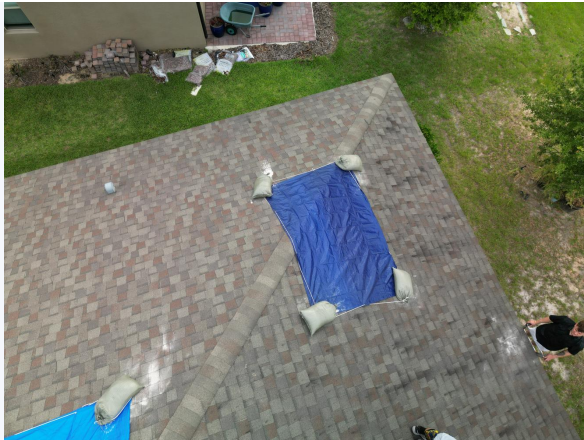
**PHOTO 1**

North slope - area consistent with possible granule loss

During our visit, we observed some areas of the north slope of the roof that appeared consistent with possible granule loss, as well as some storm debris. These observations are provided to give you a clear record of your property's condition at the time of our visit. We recommend a professional assessment to further evaluate these areas. This documentation is observational only and does not constitute a damage assessment.

- 1 Schedule a no-cost roof condition review.
- 2 Document interior ceiling stains, water marks, or active leaks.
- 3 Review exterior conditions with a qualified professional.
- 4 Homeowner decides whether to contact their insurance carrier.
- 5 Watch for changes after the next rain.

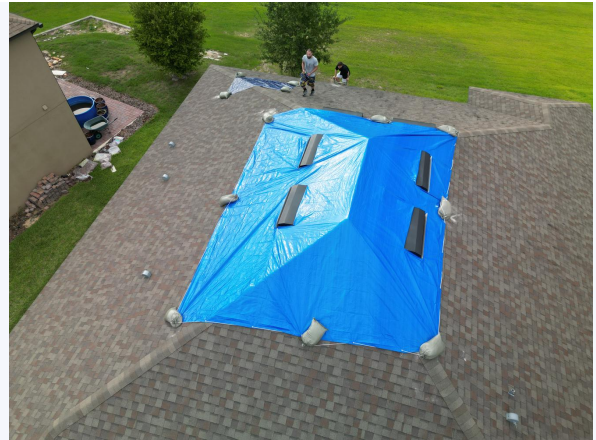
**PHOTO 2**

Roof overview - storm debris visible

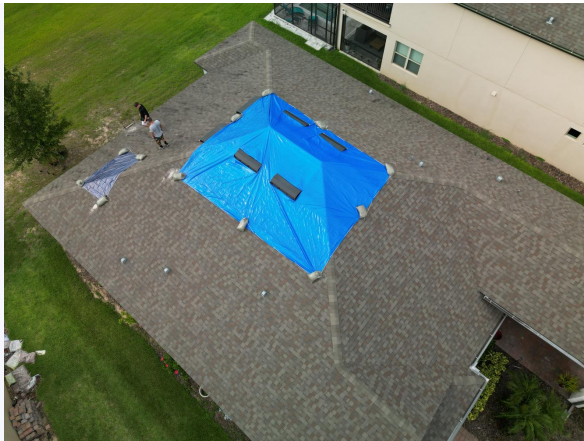
**PHOTO 3**

Roof overview - storm debris visible

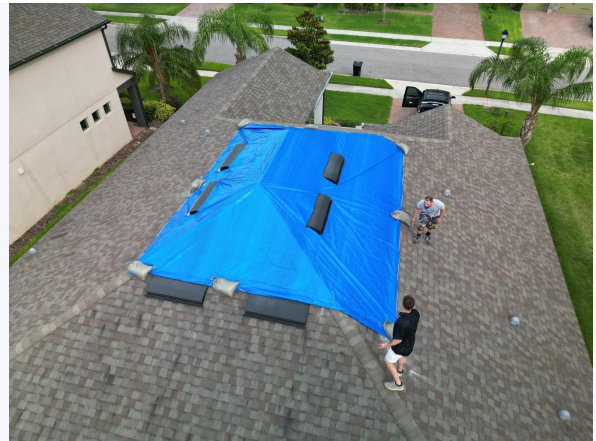
**PHOTO 4**

North slope - overview documentation

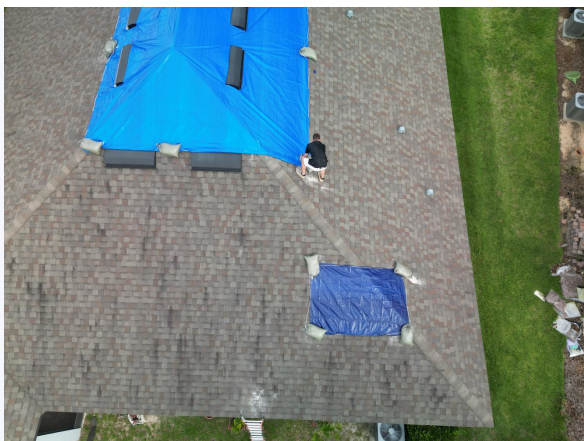
**PHOTO 5**

North slope - area consistent with possible granule loss

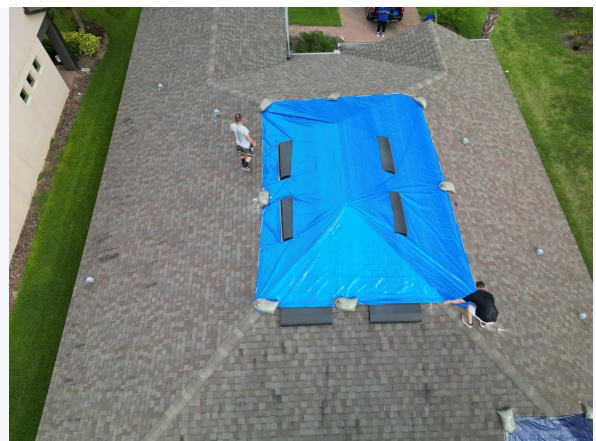
**PHOTO 6**

Roof overview - overview documentation
