## SPACE COAST EMERGENCY TARPING

# STORM EVENT & AERIAL ROOF DOCUMENTATION REPORT

2282 Panoramic Circle, Apopka, FL, 32708

May 5, 2026

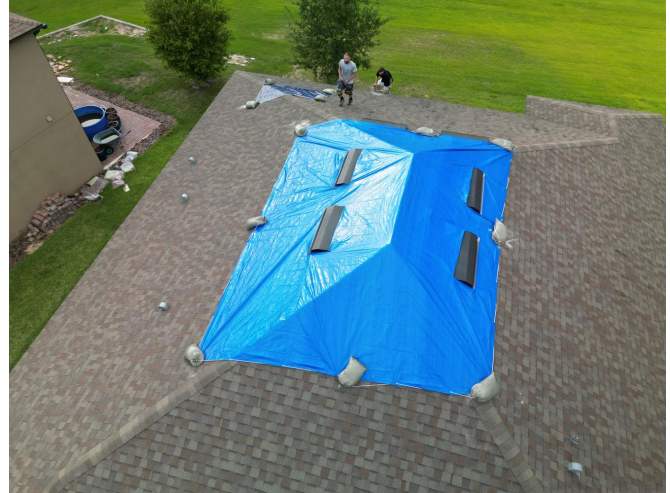
storm debris visible

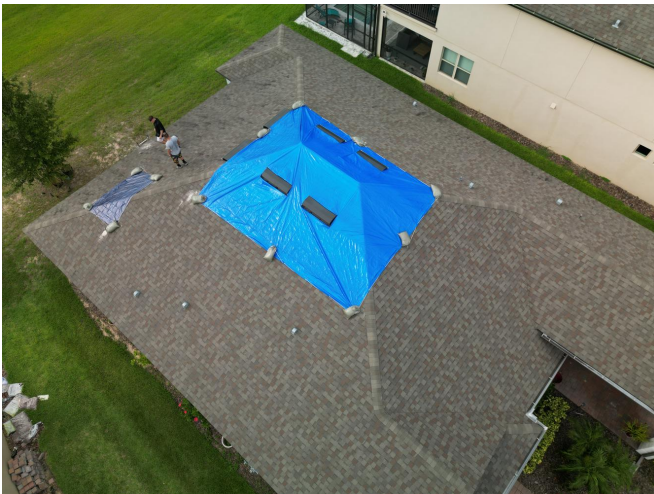
storm debris visible

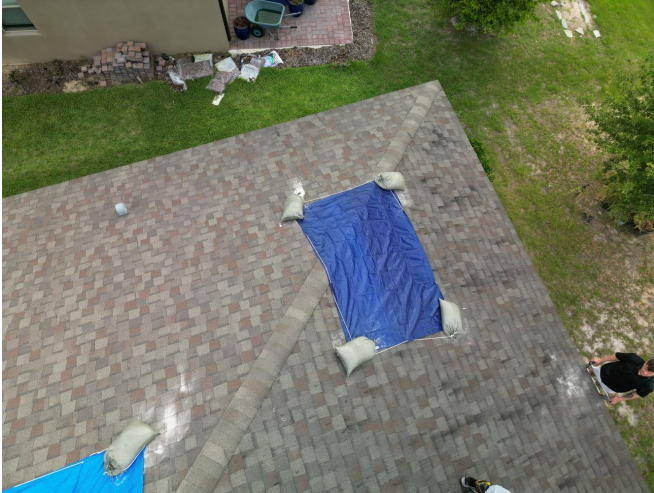
area consistent with granule loss

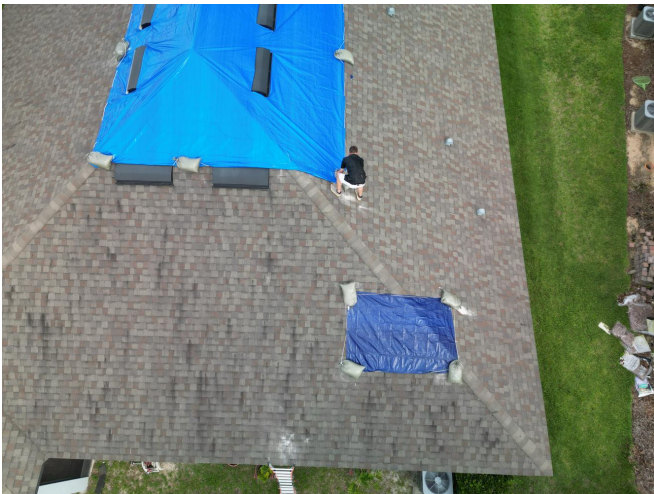
area consistent with granule loss
