# STORM DAMAGE ASSESSMENT

Aerial Documentation Report

2282 Panoramic Circle, Apopka, FL, 32708

May 3, 2026

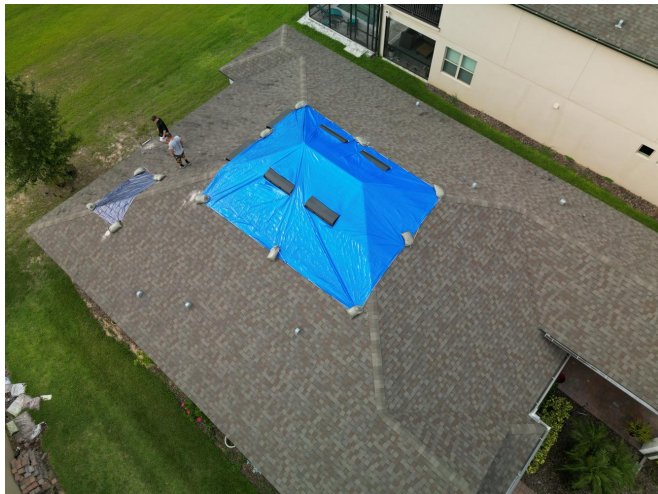
storm debris visible

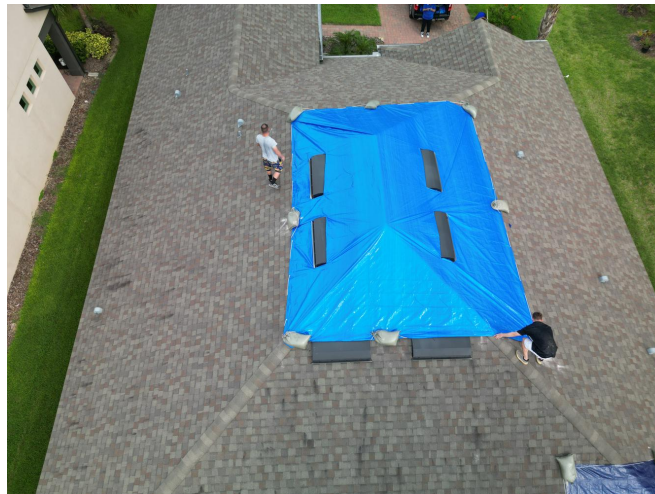
storm debris visible
